**AIRCRAFT ACCIDENT REPORT**

**MD-11F, Registration [REDACTED]**  
**King Khalid International Airport – Riyadh**  
**Kingdom of Saudi Arabia**

**Abnormal Runway Contact (ARC)**

**15 Sha'aban 1431 H – 27 July 2010 G**

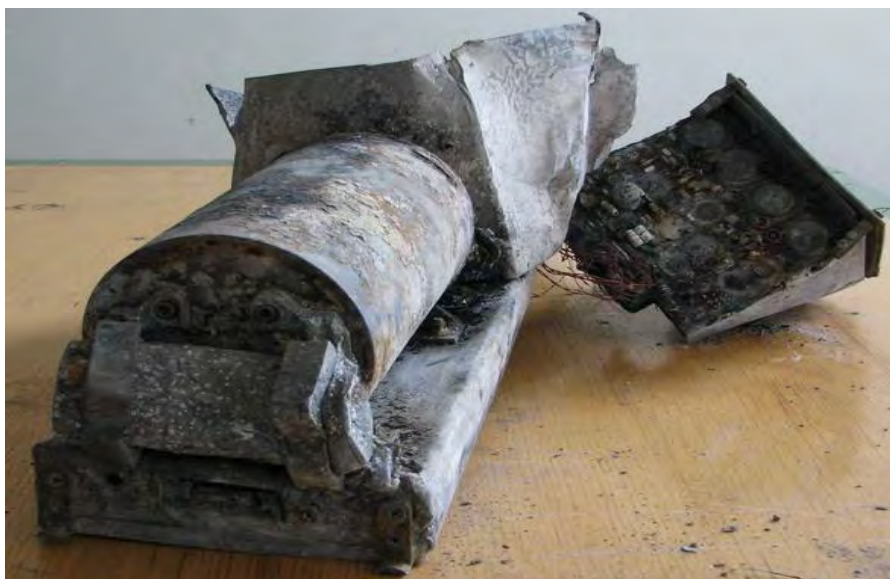
Figure 3: DFDR Unit

The recorder chassis and the Underwater Locator Beacon (ULB) had been destroyed by the fire. The Crash Survival Memory Unit (CSMU) showed minor mechanical damage with strong influence of fire on the painting and on the surface (Figure 3).

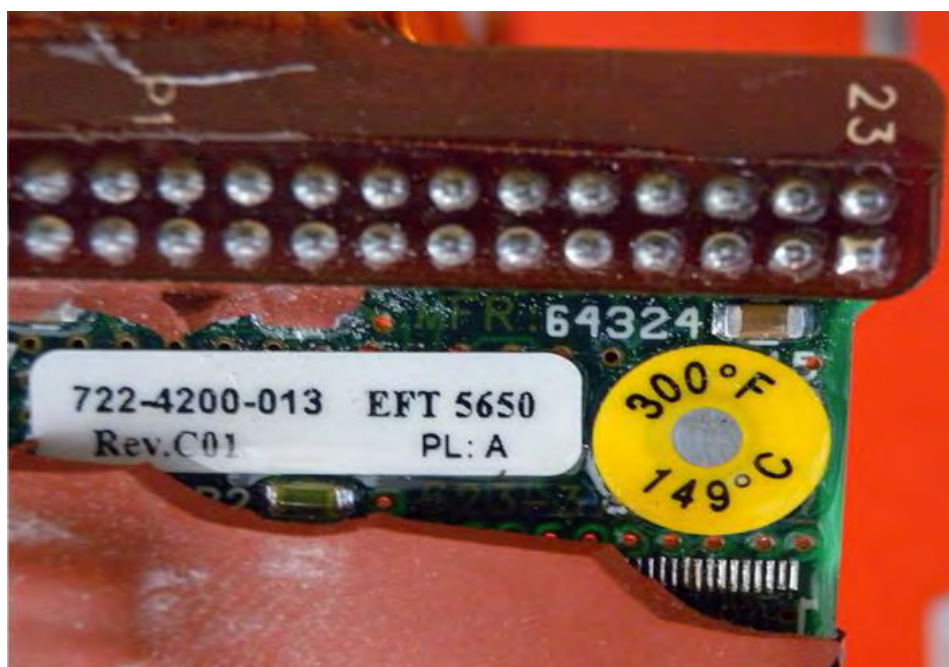
Figure 4: DFDR Memory Board

The memory board showed no damage and its temperature indicator was of a grey color indicating some heat exposure, but not critical (Figure 4).

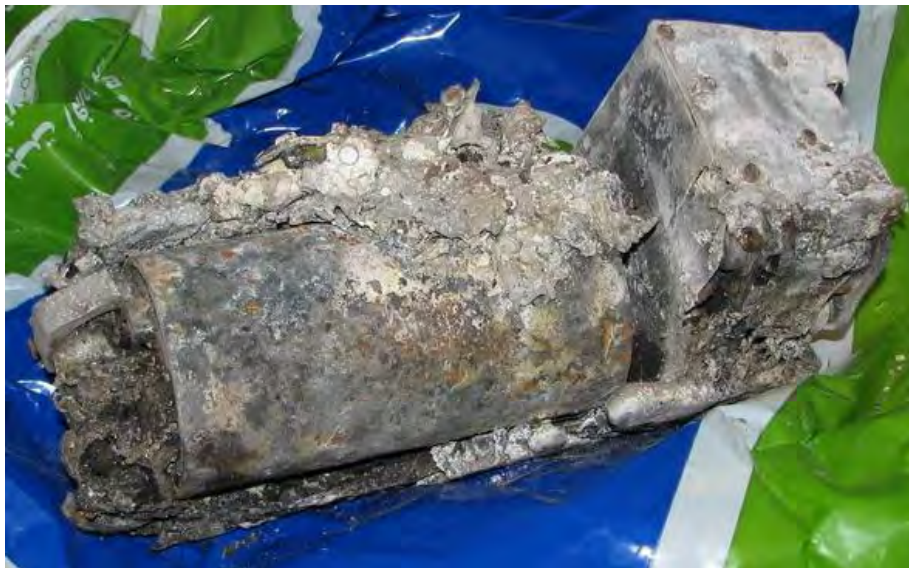
Figure 5: CVR Unit

The recorder chassis and the ULB had been destroyed by fire. The CSMU showed minor mechanical damage, strong influence of fire on the painting and on the surface and, attached molten material of unknown origin (Figure 5).

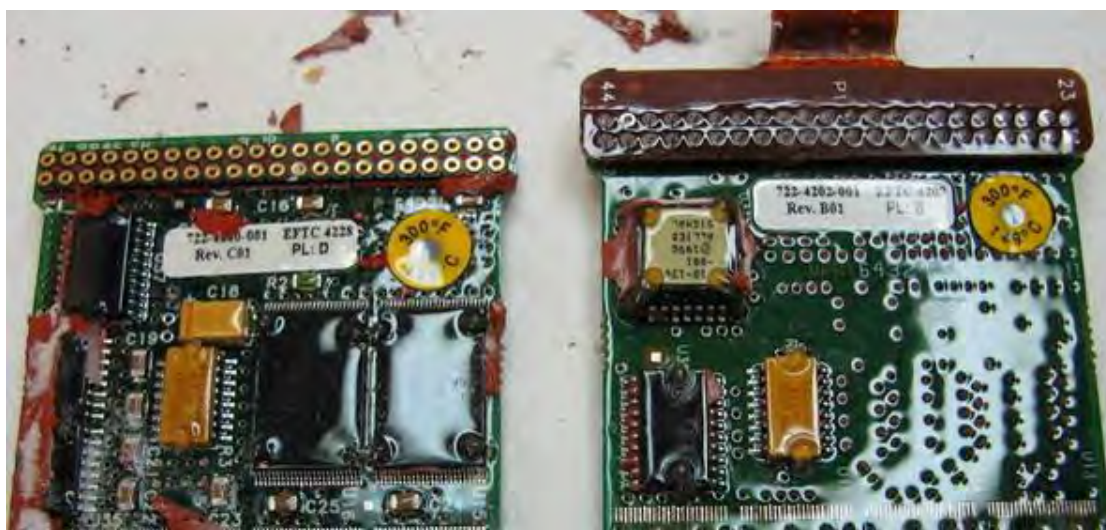
Figure 6: CVR Memory Board

The memory board showed no damage and its temperature indicator was of a grey color indicating some heat exposure, but not critical (Figure 6).

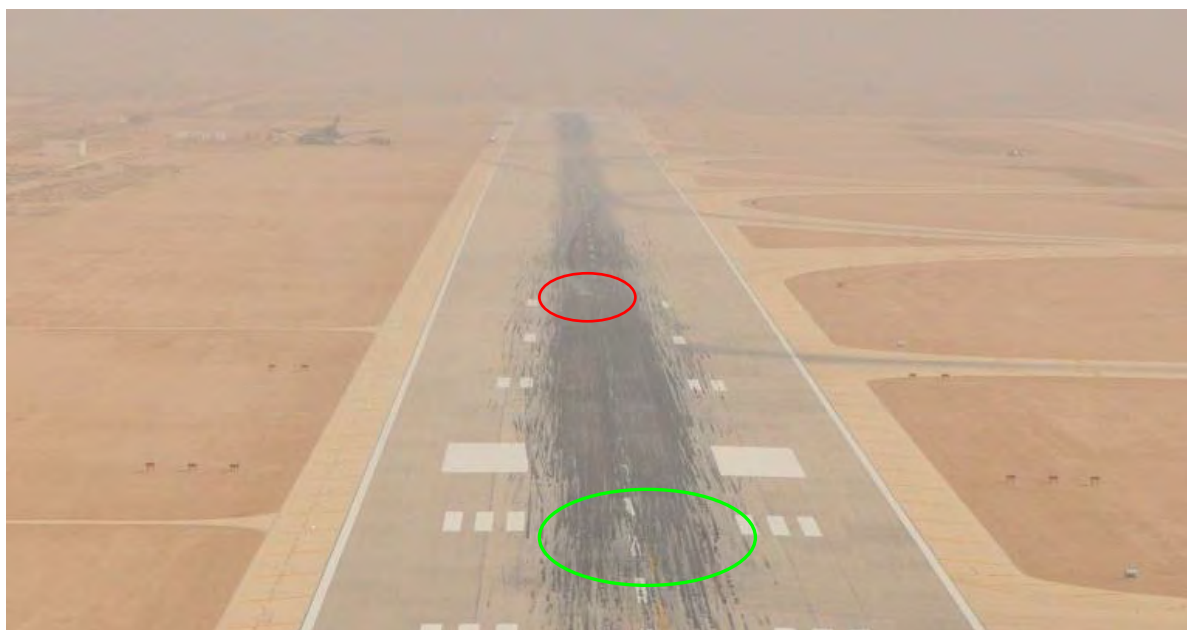
Figure 7: General View of Wreckage Trail

The aircraft landed on Runway 33L at the 945 foot runway mark (green circle). The aircraft bounced following the first touchdown, touched down a second time and bounced a second time. A third and final touchdown at the 3200 foot runway mark (red circle) resulted in the aft section of the fuselage to rupture just aft of the wing. The aircraft continued down the runway with the tail dragging until it departed the left side of the runway at the 7400 foot runway mark, where the nose gear collapsed. After departing the runway, the aircraft traveled through a gravel area before it came to rest at the 8800 foot runway mark on a heading of 310°, 300 ft left of runway 33L centerline, across from taxiway exit A5 (Figures 7 and 8 and, Figure 3 of Appendix C). A fire started after the rupture of the aft fuselage.

- Six parallel stripes of rubber residue were found 945 ft from the runway threshold indicating that the aircraft touched down with the two main landing gears and the centre landing gear. (Figure 7 - green circle and Figure 9 – green arrows);

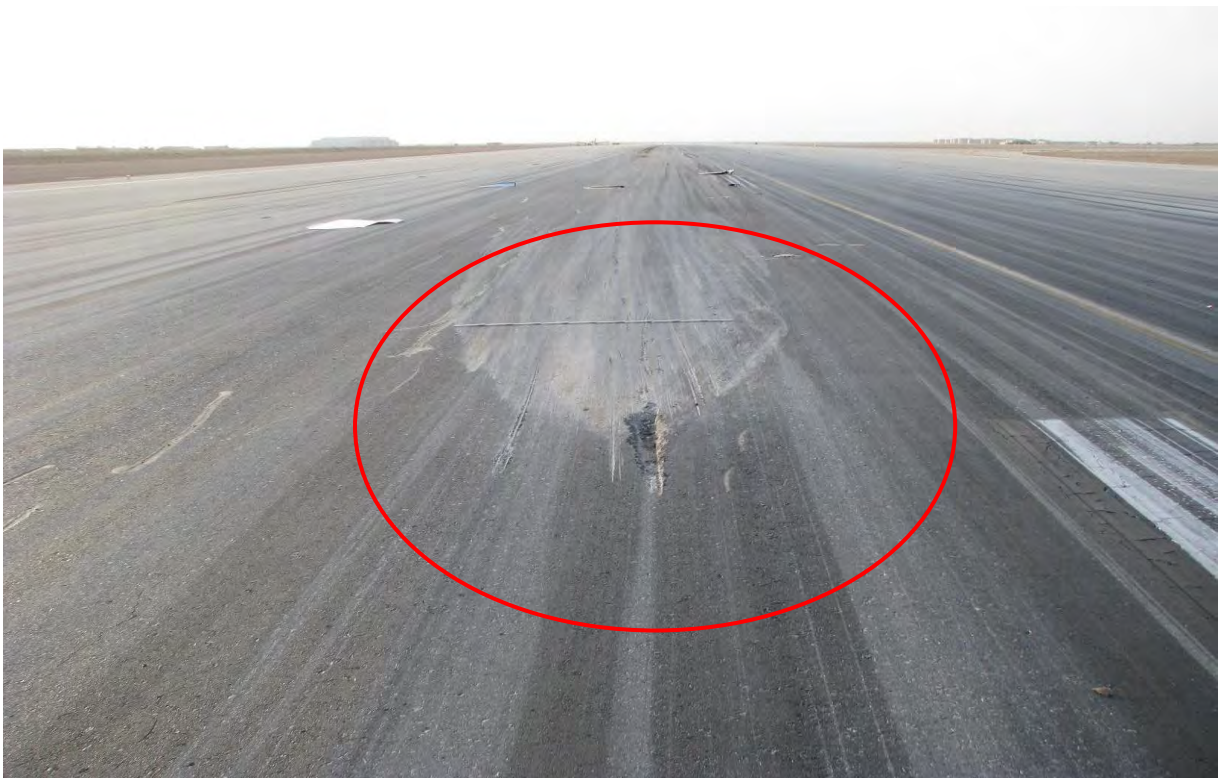
Figure 10: Tail Impact following Rupture of Fuselage

The runway scars and the condition of the wreckage indicated that after the last touchdown, the rear section of the fuselage behind the wing ruptured and collapsed, folding towards the runway about a “hinge” on the bottom of the fuselage in the area of the rupture.

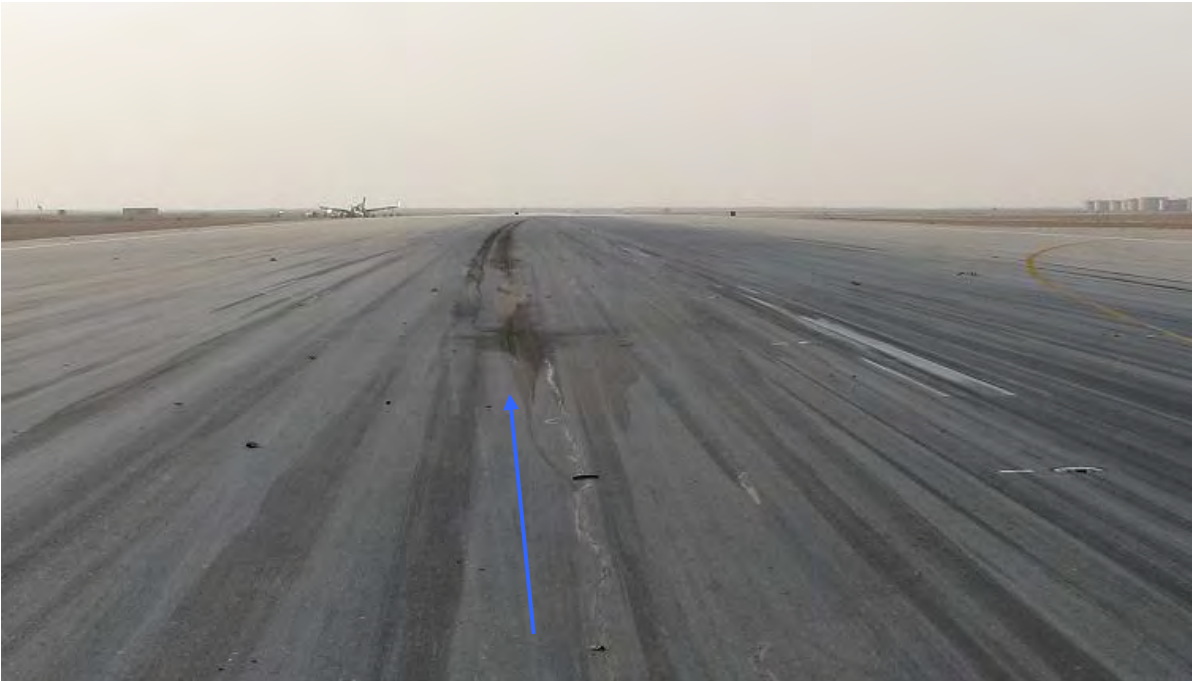
Figure 11: Centre Gear

- Starting at a point 3,500 ft from the threshold and slightly left of the runway centreline, two parallel stripes of rubber residue were found. The lateral distance of the stripes indicated that the traces came from the centre landing gear. (Figure 11 - blue arrow);

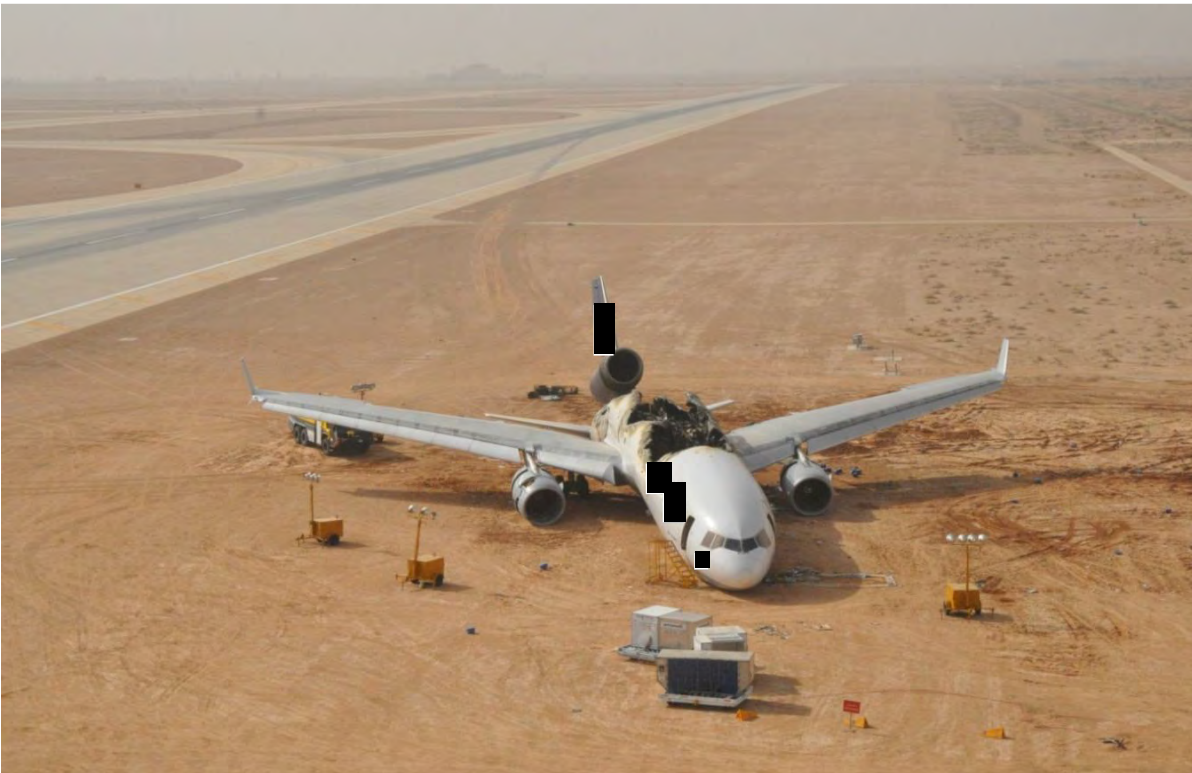
Figure 12: Main Wreckage

- Trace of the aircraft (off the runway). This trace leads directly to the main wreckage (Figure 12); and
- Main wreckage located 8800 ft from the threshold and 300 ft to the left of the runway centreline (Figure 12).

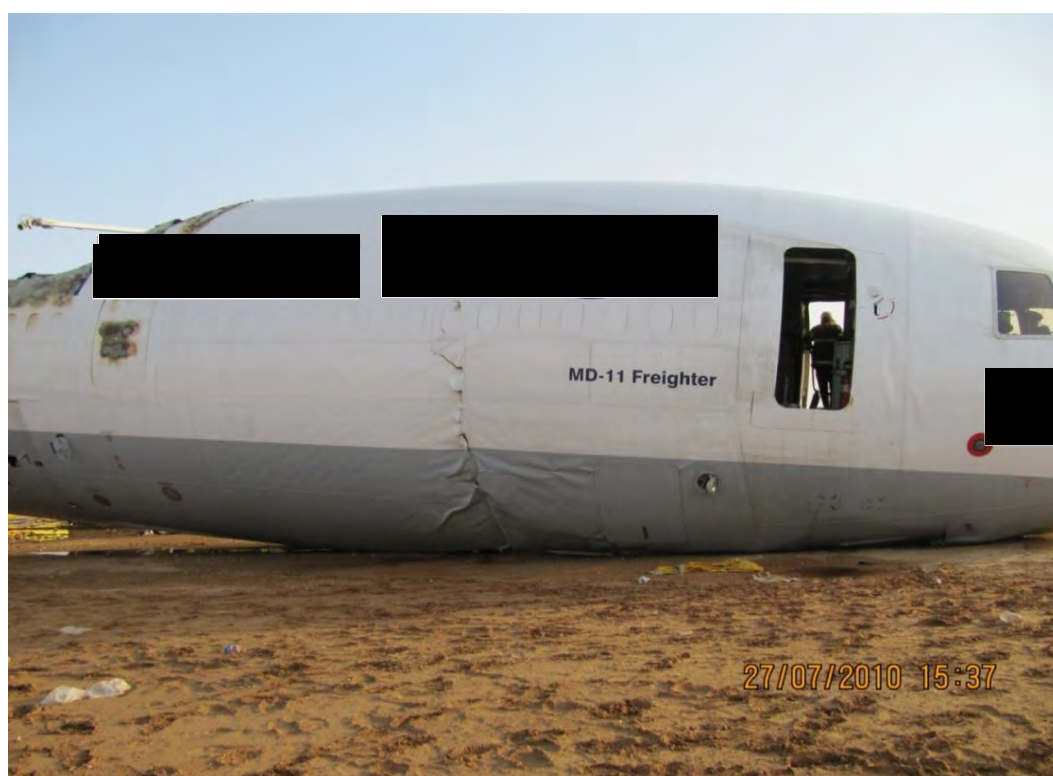
Figure 13: Buckling of Right Forward Fuselage

There was fuselage buckling at FS 595 on the right side of the fuselage from the windows down. This buckling was severe and included skin tears and deformation. Less severe skin buckling was noted at various locations on the lower half of the fuselage from FS 595 forward to approximately FS 410 (Figure 13).

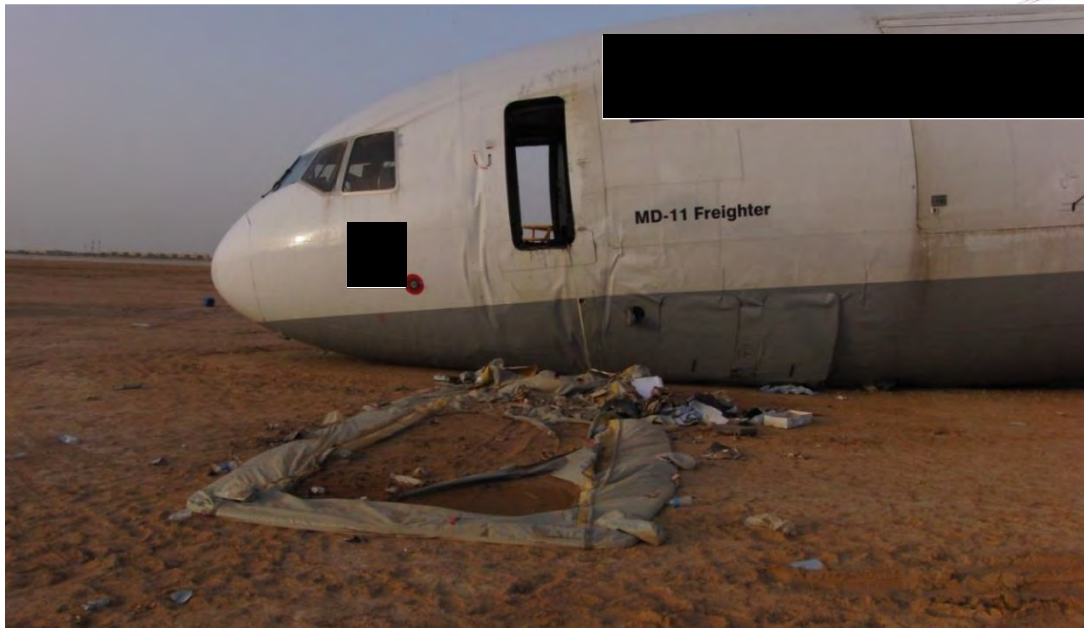
Figure 14 : Buckling of Left Forward Fuselage and Deflated Slide

The aircraft fuselage was ruptured into two (2) major sections. The rupture was located at Fuselage Station (FS) 1441 just aft of the wing. The forward half section was supported by the main landing gear, which remained in the down position. The nose gear had collapsed aft and had punctured the forward lower cargo compartment, causing some crush damage to the lower fuselage and allowing the nose to rest on the ground. The nose gear was missing both tires, the right wheel and half of the left wheel. The slide had been activated at the L1 door. The slide was deflated and was resting on the ground detached from the aircraft (Figure 14).

The left side of the fuselage showed skin buckling from FS 595 forward to FS410 (Figure 14).

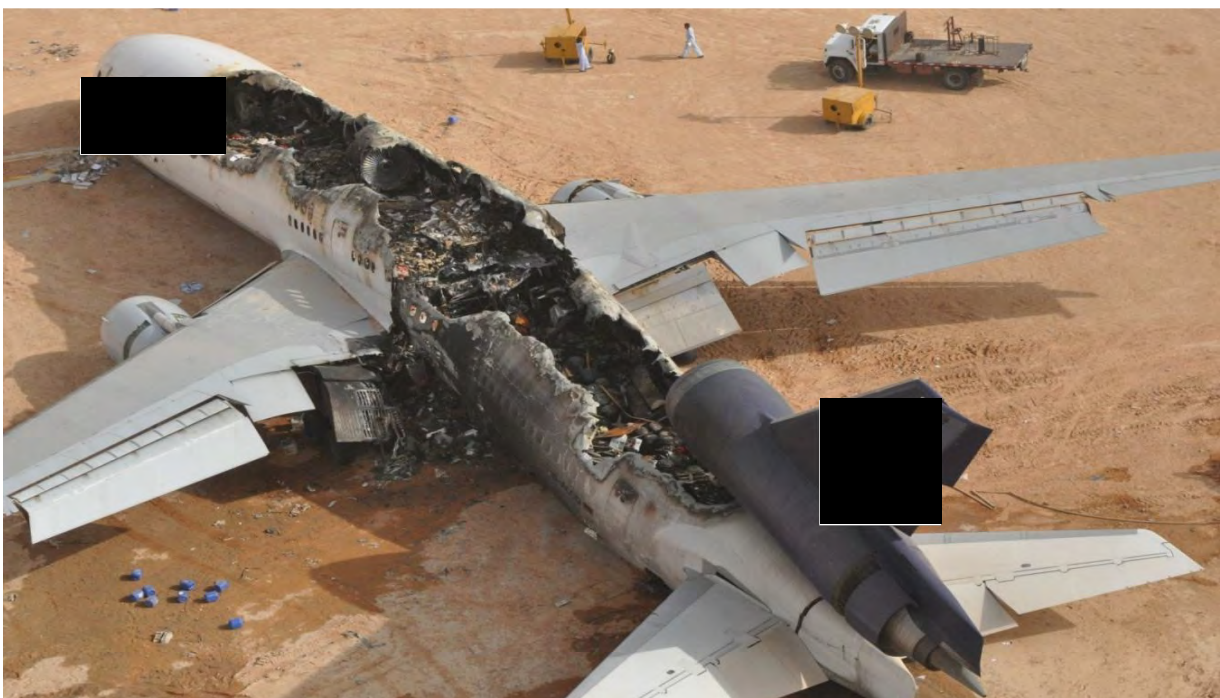
Figure 15: Fire Damage – Main Cargo Compartment

The top of the fuselage was burned through starting at FS 789 aft to the no.2 engine mount at FS 1986 (Figure 15). The fire consumed much of the cargo in the main deck compartment with the least amount of fire damage located at the forward end near the cockpit. The cockpit exhibited light soot deposits and the forward lower cargo compartment was undamaged by fire; the only damage to this compartment was from the nose gear which punctured through the floor. The aft lower cargo compartment was not accessed as the main deck cargo floor had collapsed into this area and it was filled with burned debris.

The left wing root area displayed significant fire damage. The structure and skin on the lower half of the fuselage in the main gear area was largely consumed by the fire (Figures 15, 23 and 24).

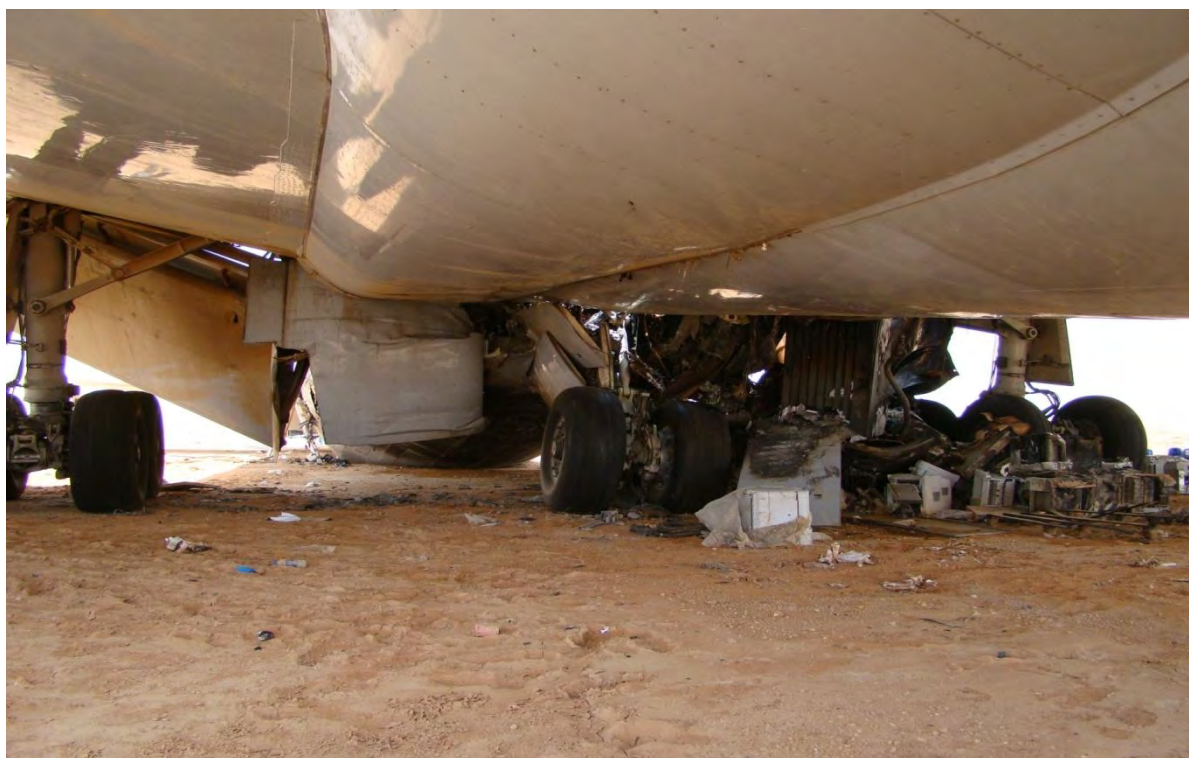
Figure 16: Main Landing Gear

The left main landing gear remained intact (Figure 16). The wing rear spar, upper fixed brace, upper side brace, lower side brace, lock links, strut (PN NRG6719-501, S/N BFGS 01027) and truck had no visible damage that would suggest gear failure or strut over-compression. The chrome extension on the strut measured 4.75 inches (in.) and the paint below the chrome did not demonstrate signatures of strut over-travel. All four (4) tires were inflated.

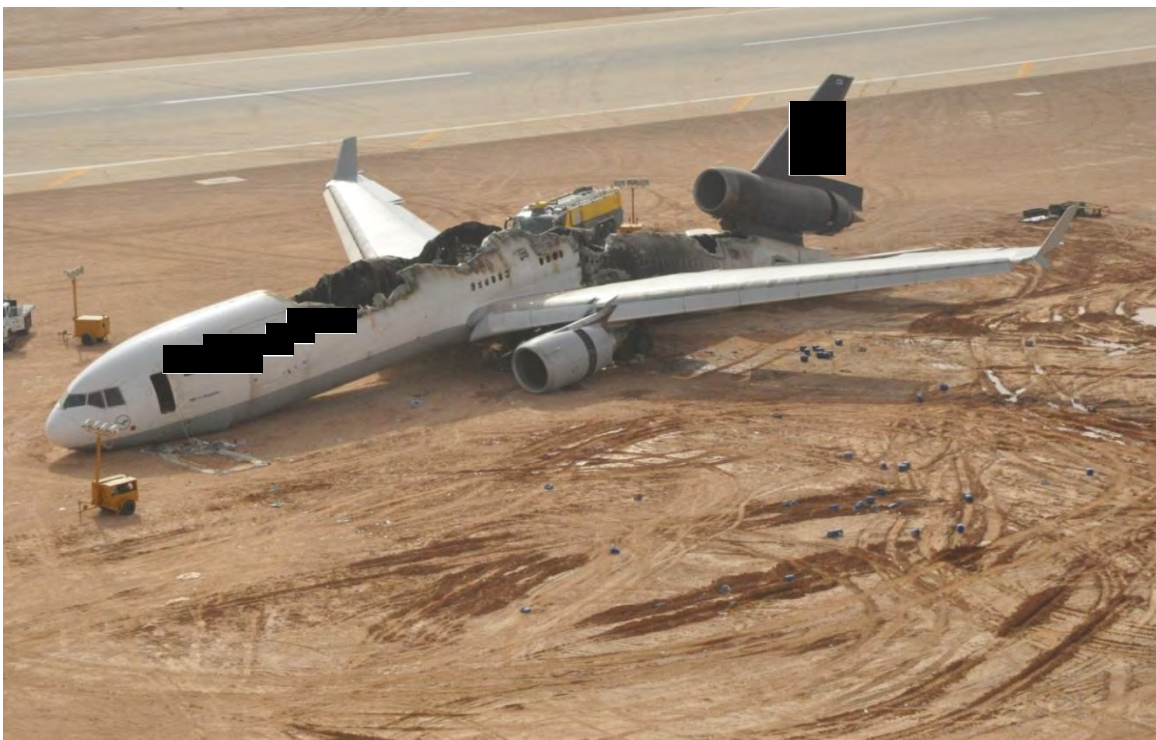
Figure 17: Extended Leading Edge Slats

The left wing was mostly undamaged with the exception of fire damage on the aft inboard area. The inboard flap was damaged by fire and remained attached to the wing at the outboard end only. The flap actuator was covered in soot with some shiny chrome extension on the piston near the actuator housing. The inboard aileron was in a downward position and also demonstrated some discoloration due to fire. The outboard flap was extended and appeared to be at or near the end of the flap tracks. The outboard aileron was slightly up and the leading edge slats were fully extended (Figures 17 and 18).

The right wing was mostly undamaged with the exception of the aft inboard area, which damage was not as extensive as to the left wing. The inboard flap remained attached to the wing at the outboard end only. The inboard side of the flap was tucked under the trailing edge of the wing. There was some damage to the trailing edge of the wing in this area that appeared consistent with the flap being torn out from the wing. The inboard aileron was in a downward position. The outboard flap was extended and appeared to be at or near the end of the flap track. The outboard aileron was slightly up and the leading edge slats were fully extended (Figures 17 and 18).

The right horizontal stabilizer leading edge measured 12 in. below the reference line on the fuselage. The outboard elevator was in a slightly down/faired position, while the inboard elevator was in a mostly down position. The vertical stabilizer and the rudder appeared in good condition. The top half of the rudder was deflected more to the right than the lower half (Figures 17 and 18).

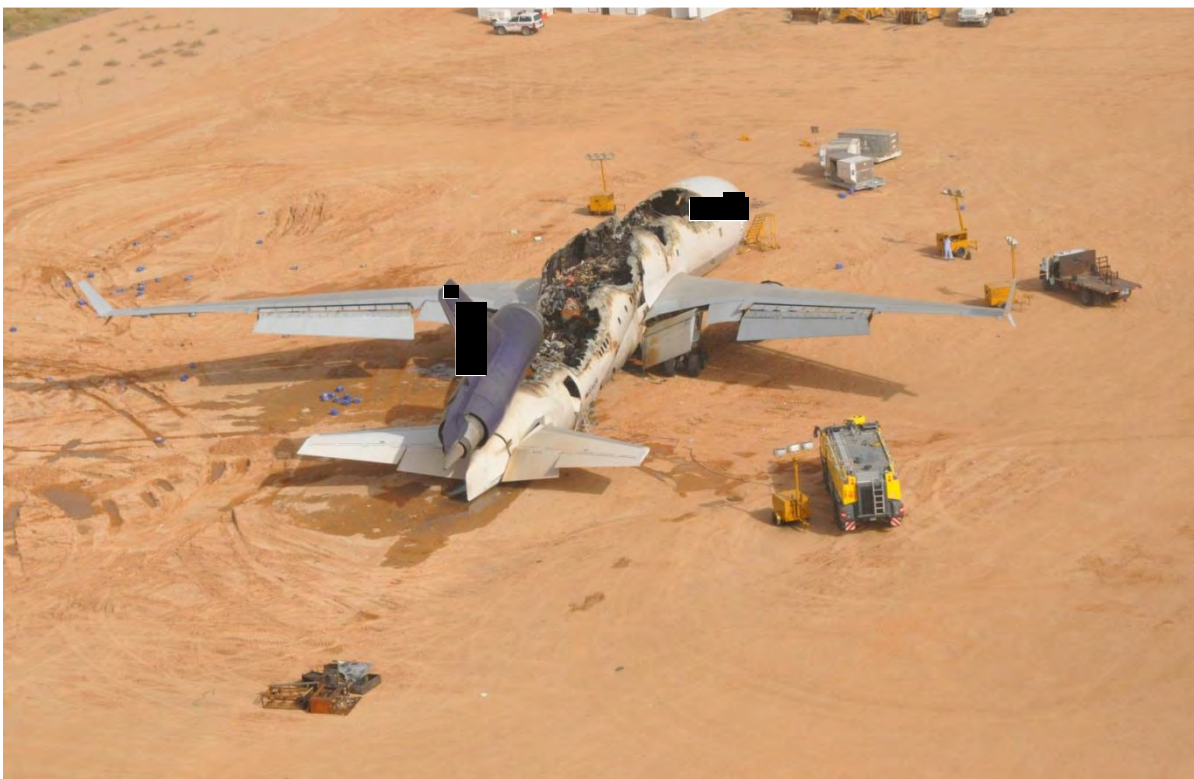
Figure 18: Position of Flight Control Surfaces

The aircraft exhibited wide-spread fire damage particularly in the crown area of the fuselage aft of the wing. The fire damage to the crown began just aft of the forward cargo door and extended to the engine mount of the no. 2 engine (Figures 15, 17 and 18).

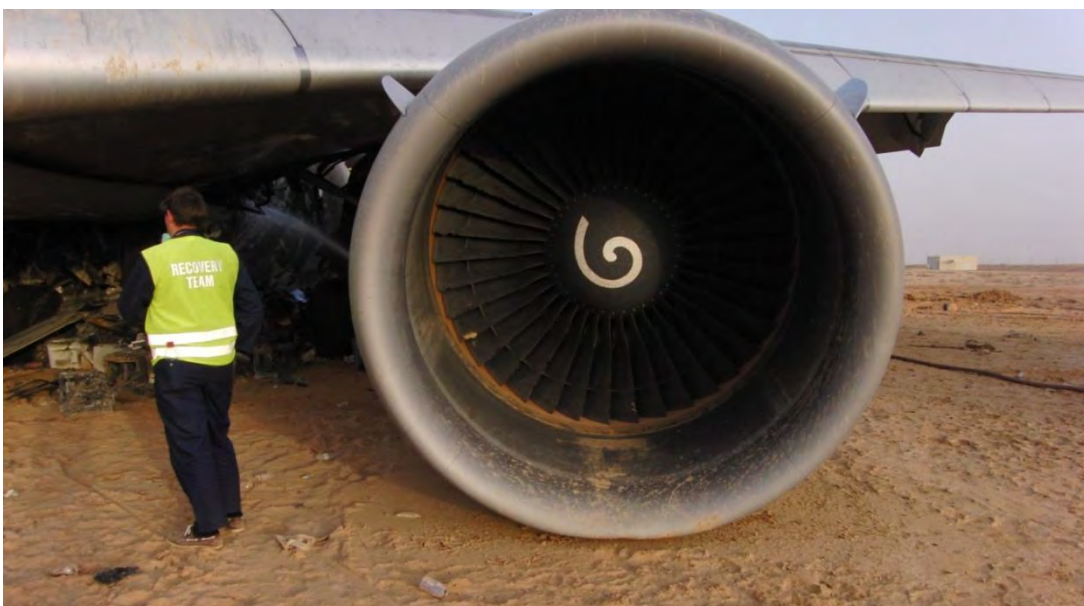
Figure 20: Left/No. 1 Engine

The engine remained attached to the wing with the front of the engine resting on the ground. The first row of fan blades had some damage on the leading edge of the blades. The first row of stator vanes was intact. Both reverser sleeves were extended and all blocker doors were closed. The reverser exhaust cascades appeared relatively clean, containing only a small amount of dirt and debris. A visual inspection revealed that the last row of turbine blades was in good condition and all blades were accounted for (Figure 20).

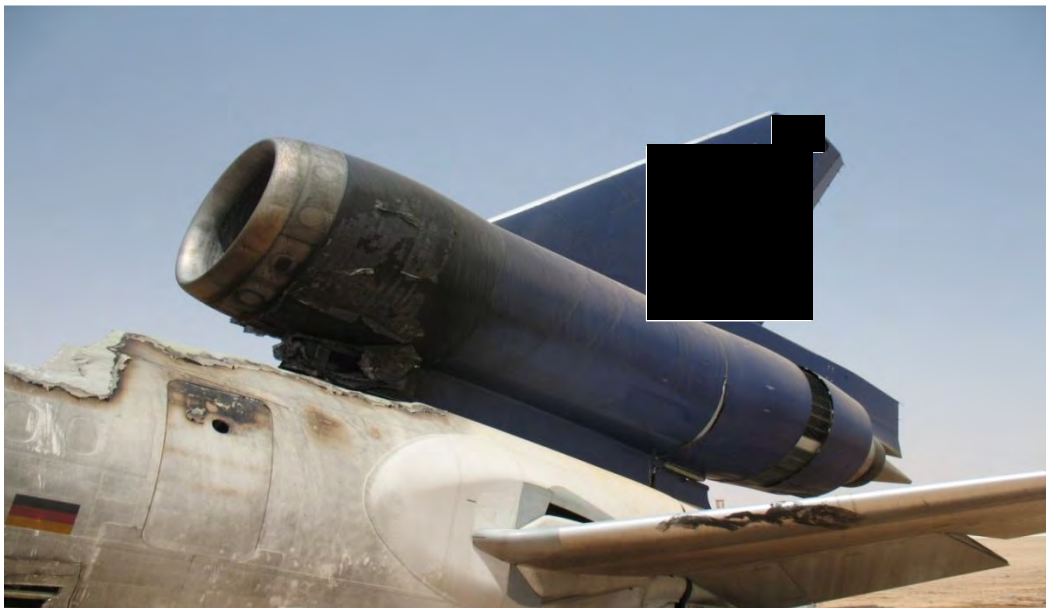
Figure 21a: Centre/No. 2 Engine

The engine was attached to the tail/vertical stabilizer. The inlet engine housing was damaged by the fire in the fuselage. There was a gap on the engine pylon fairing at FS 2162 and the left side of the engine nacelle was split at this location. The right side reverser sleeves were retracted and the blocker doors appeared open. The left side reverser sleeves were extended and the blocker doors were closed. There was a small amount of unidentified debris in the reverser exhaust. A visual inspection revealed that the last row of turbine blades appeared in good condition (Figures 21a and 21b).

The forward portion of the no. 2 engine cowling had heavy soot with the left side of the cowling exhibiting heavier damage than the right side. The forward edge of the engine mount showed evidence of melting (Figure 21a).

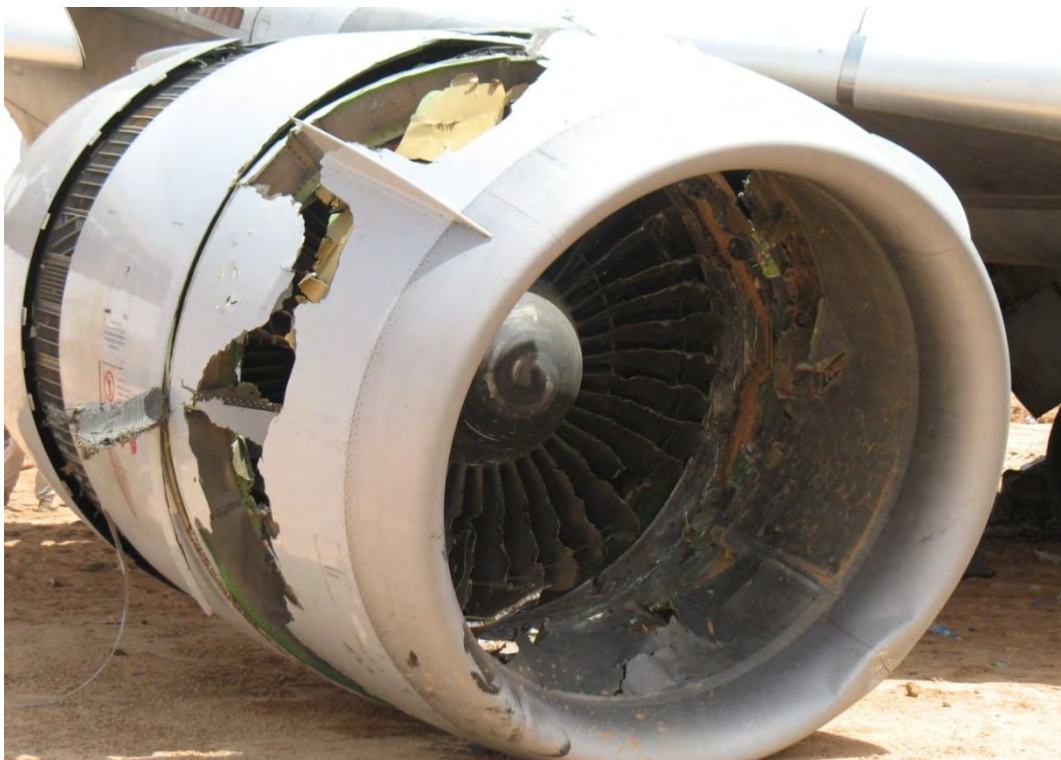
Figure 22: Right/No. 3 Engine

The engine remained attached to the wing with the front of the engine resting on the ground. The engine intake cowling was damaged and mostly separated from the engine. There was a seventeen (17) in. long black mark on the intake leading edge. There was one (1) ft by 1 ft piece of nose gear tire lodged in the outboard housing where the intake cowling had separated from the engine. The first row of the fan blades and stator vanes had sustained substantial damage. Both reverser sleeves were extended and all blocker doors were closed. The reverser exhaust cascade contained debris consisting of dirt, engine nacelle and tire material. A visual inspection revealed that the last row of blade vanes appeared in good condition (Figure 22).

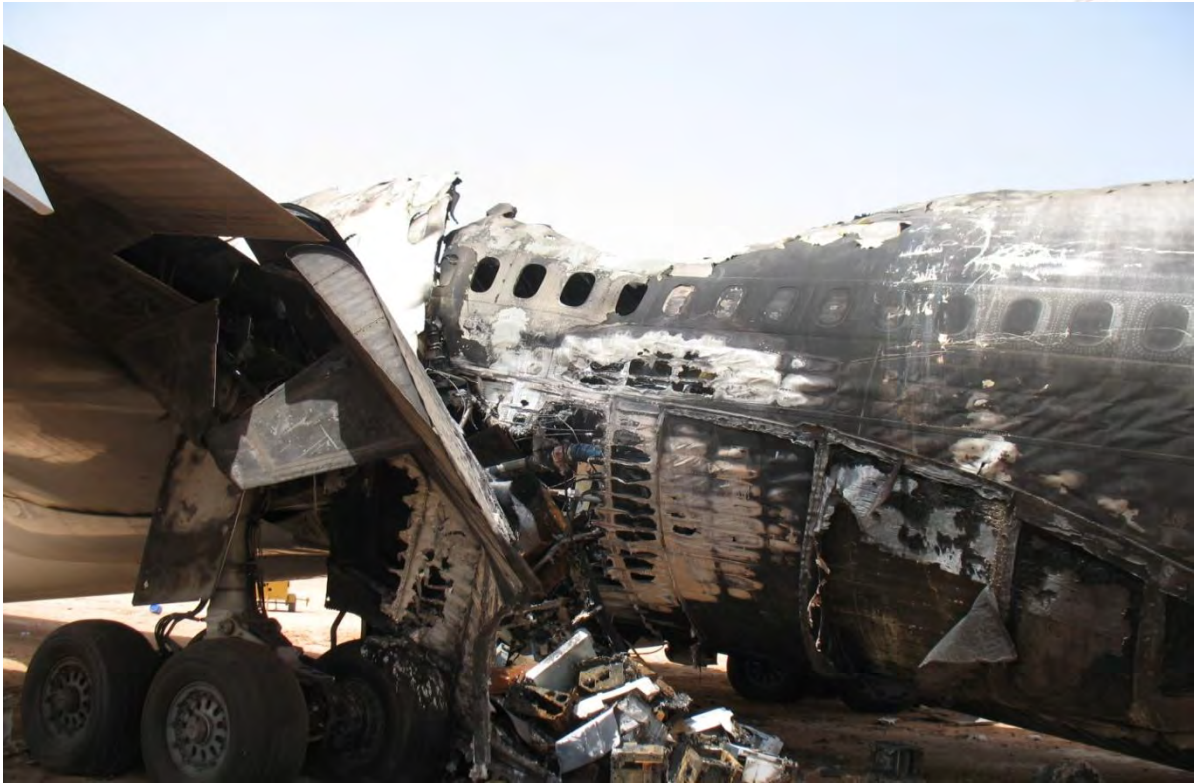
Figure 23: Area of Heaviest Fire Damage (Left Side)

The upper crown of this area of the fuselage was completely destroyed with all of the fuselage skin missing and most of the stringers either missing or melted. The fire damage extended down the sides of the fuselage to approximately half the height of the main cargo deck. In several places, the damage extended to the aft lower cargo deck. The upper edges of the remaining fuselage were melted with bubbled or missing exterior paint. The area of heaviest damage was located on the left side of the aircraft just aft of the wing where the aircraft fuselage ruptured. This area exhibited heavy melting of the fuselage as well as large areas of missing material which extended underneath the aircraft. In this area, the main cargo floor was damaged and as a result, several pieces of fire damaged cargo fell out of the aircraft after it came to rest. The center landing gear well shroud was melted, as was its upper structure (Figures 23 and 24).
